FEEL THE PULSE

Cut through the complexity of machinery analysis by adopting a simple solution that can see data on your mobile device.

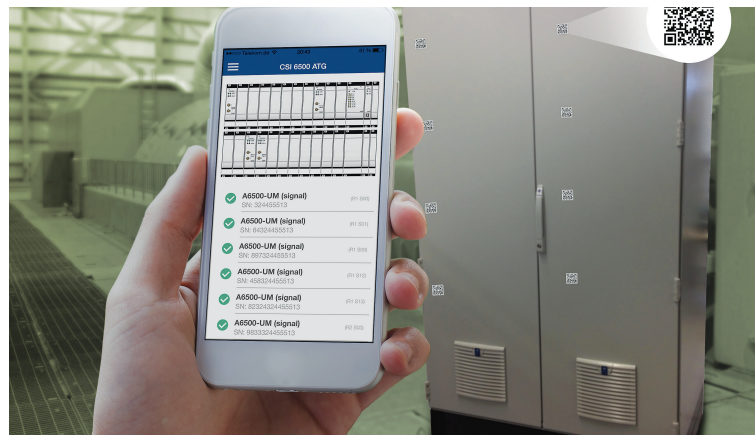
CSI 6500 ATG View delivers asset health information to the user anywhere on the plant network. Scan a quick response code (QR) located on the cabinet and data from the associated rack is viewable on the device screen.

With the CSI 6500 ATG the reliability professional can react to problems earlier leading to planned, instead of reactive, maintenance. The technology can be networked over Ethernet and/or a wireless router to deliver asset health information to authorized users through a PC or phone application anywhere in the plant’s WiFi network. This will enable the reliability professional to monitor the overall health of his system. In addition, the CSI 6500 ATG offers easy integration with third-party systems, because it is the first protection system to include a secure embedded OPC UA server. ■
