# Lower Berkeley County solves coating issues in primary sludge line with electrode coating diagnostic

Wastewater treatment plant primary sludge transfer measurement

Berkeley County Water & Sanitation; Lower Berkeley Wastewater Treatment Plant, Goose Creek, SC

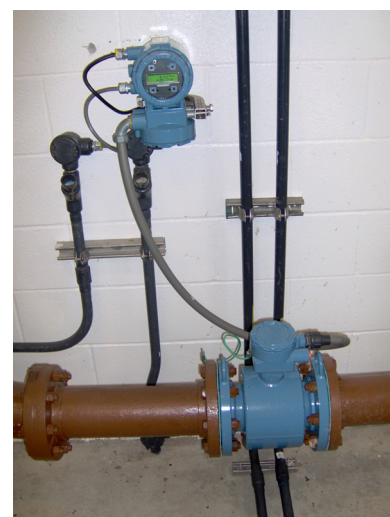
*Installed Rosemount 8750WA Magnetic Flowmeter*

Rosemount 8750WA Magnetic Flowmeter solved the problem of electrode coating. The 8750WA tube was replaced with a tube using bullet-nose electrodes. A transmitter with the electrode coating diagnostic was installed. The diagnostic monitors the electrode resistance value changes caused by build-up on the electrodes. By determining the electrode resistance value just prior to a failure, the meter was set to warn the operator before that value is reached.

*“Between switching to bullet electrodes, flushing the system and the coating diagnostic we have not had a failure since.”*
